BGT

GEARBOX SERIES 大型齒箱系列

GEAR REDUCER SERIES

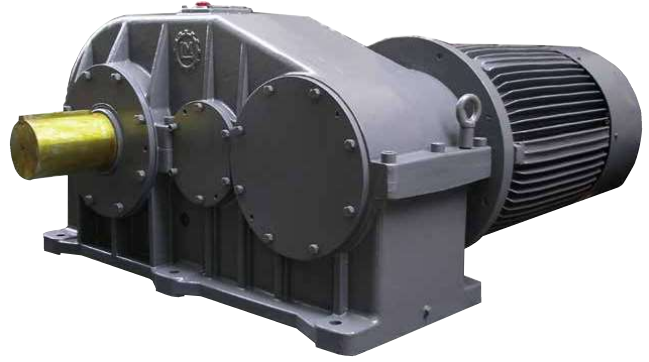
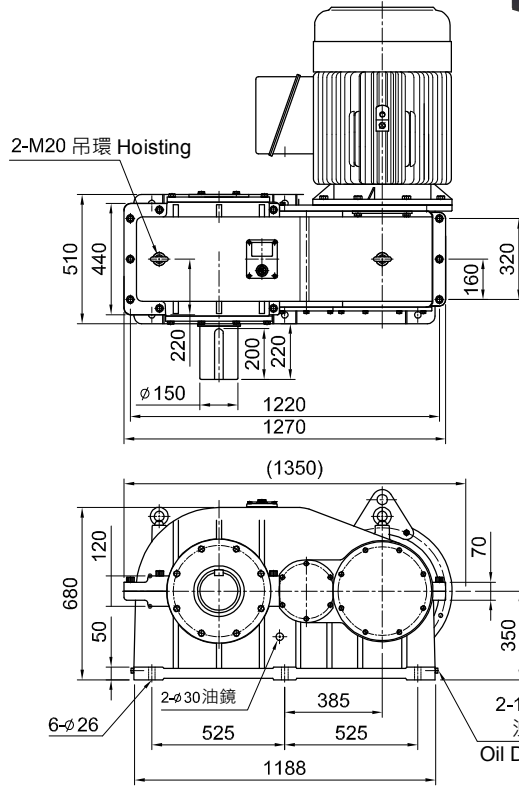
MODEL : BGT150 □ M

RATIO : 10, 15, 20, 30

125HP x 4P

◆ 大型馬達 (75HP、100HP、125HP、150HP) 軸心處若有排油孔，會產生漏油現象，建議使用 BGT150 □ B 自裝式或 BGT150 □ D 雙軸式。

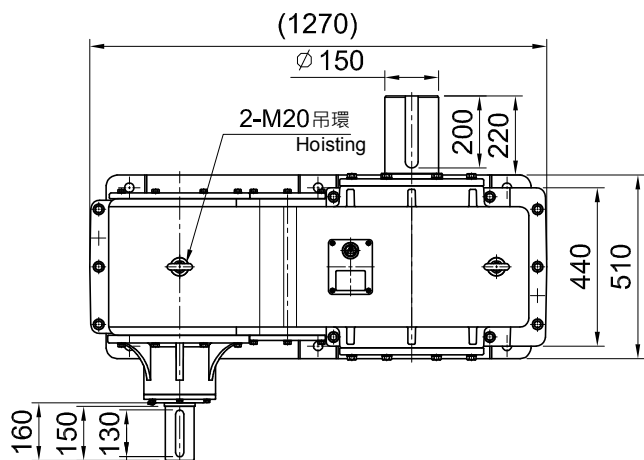
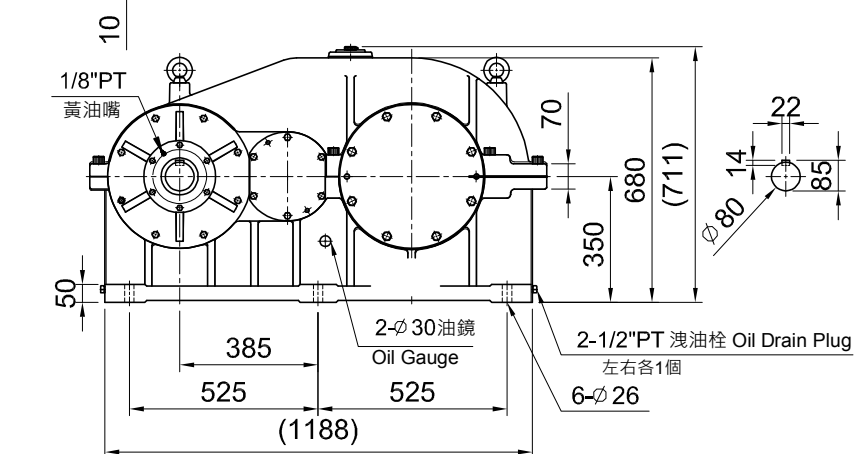
MODEL : BGT150 □ D

RATIO : 10, 15, 20, 30

馬力 (HP) : 75, 100, 125, 150
